TRESTLE FOREST
HEALTH PROJECT
HYDROLOGY REPORT

October 10, 2014
(Minor additions on June 13, 2017)

Steve G. Markman, Hydrologist

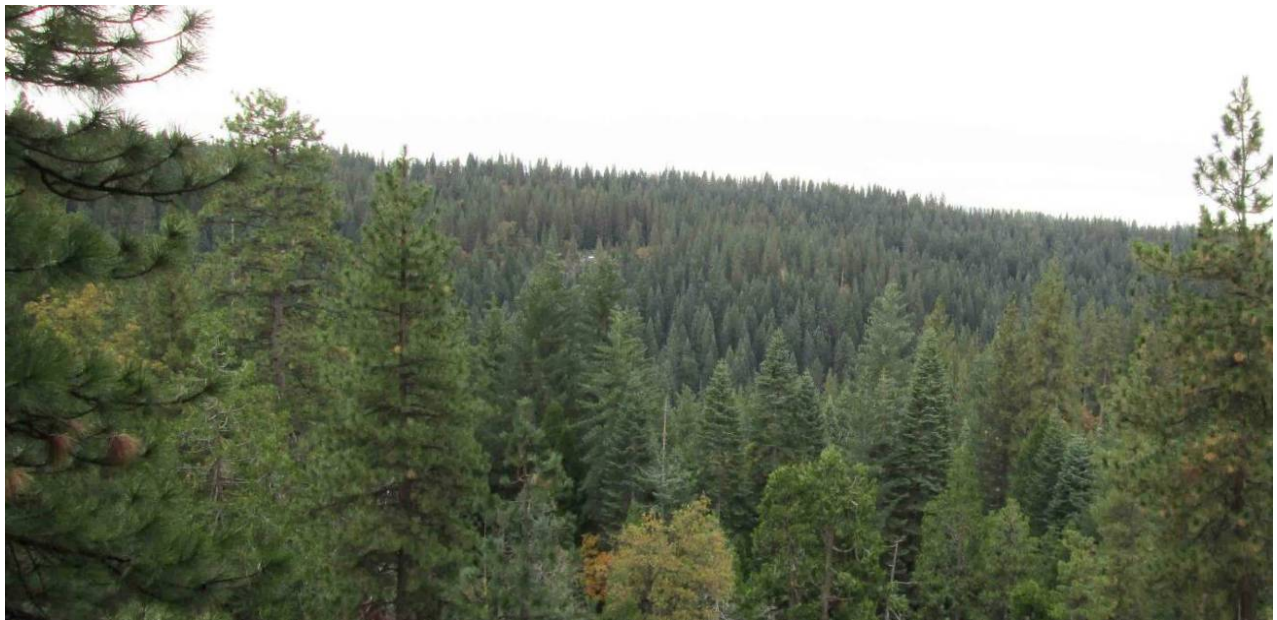
Figure 1. A portion of the Dogtown Creek watershed at an elevation of approximately 4,400 feet.

The landscape of the TFHP is mountainous and forested (Figure 1) in the headwaters of the Cosumnes River drainage basin (Figure 2), and includes a portion of seven watersheds at the HUC 7 scale (Figure 3).

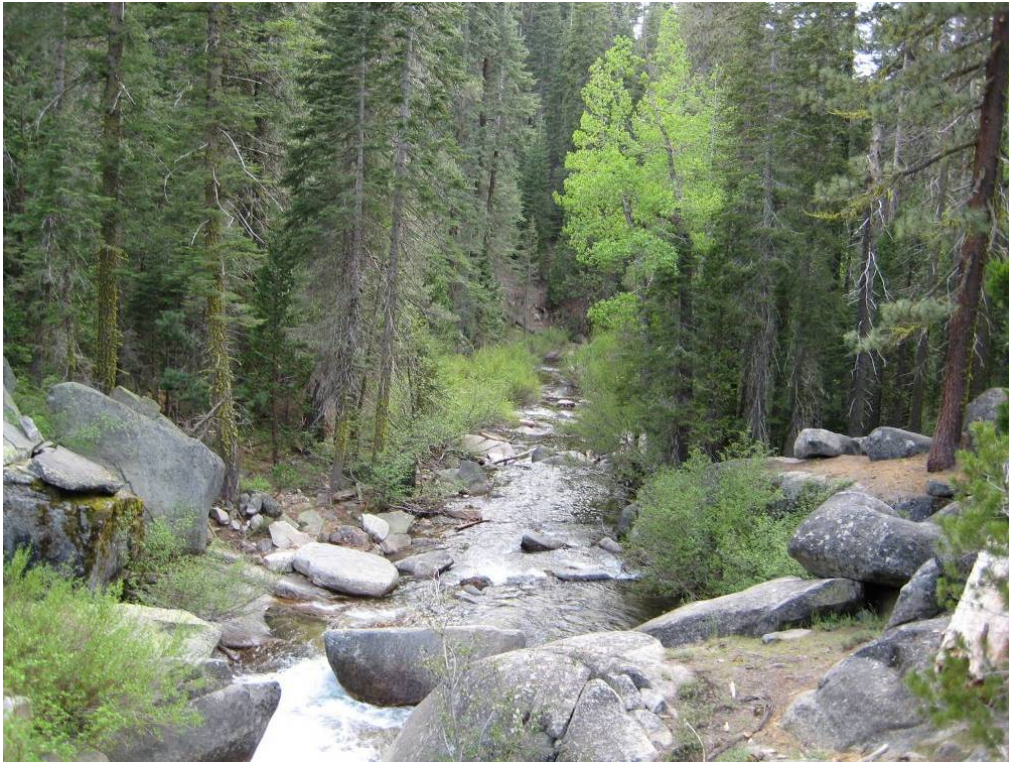
Figure 3. Watersheds (HUC 7 scale) that contain the Trestle Forest Health Project (TFHP).¹

¹ Map shows the largest perennial streams – intermittent and ephemeral streams are not shown. HUC = hydrologic unit code.

¹ The location of streams is shown in Figure 3.

- Wildfires have occurred in the project area in several watersheds, as evidenced by areas of burned trees.
- The TFRP would involve a number of vegetative management activities in a portion of seven watersheds (HUC 7 scale). The watersheds are shown in Figure 3 in the section *Affected Environment*.

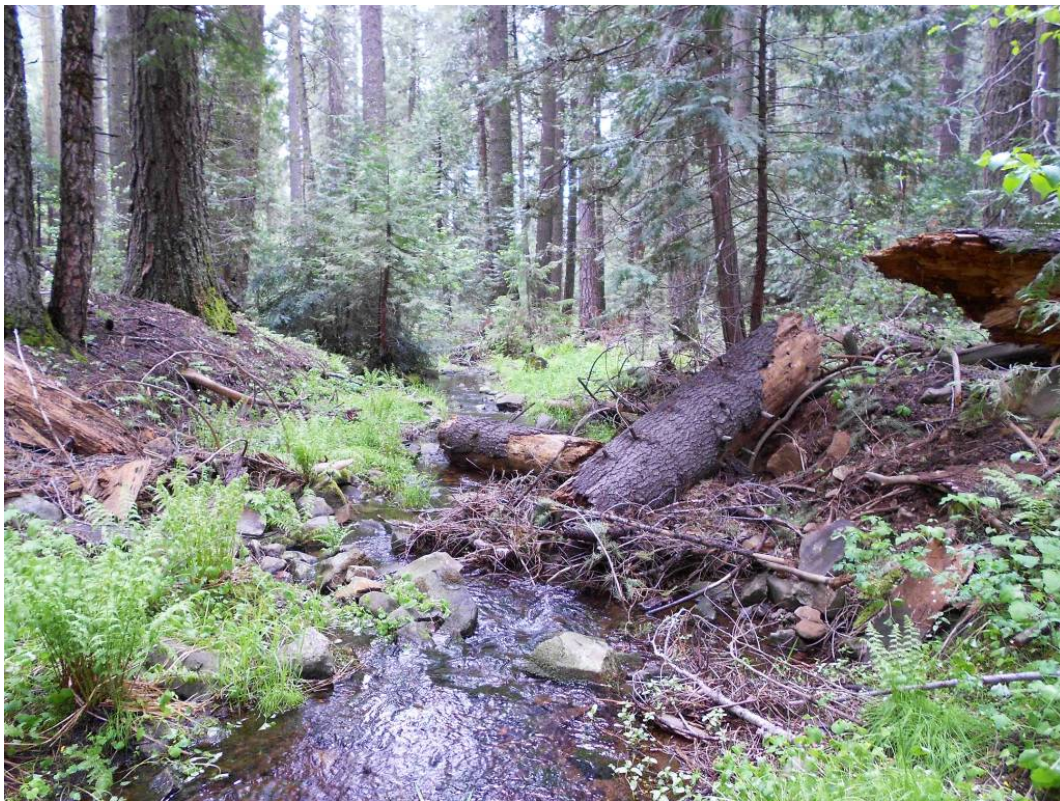
Figure 4. North Fork Cosumnes River.

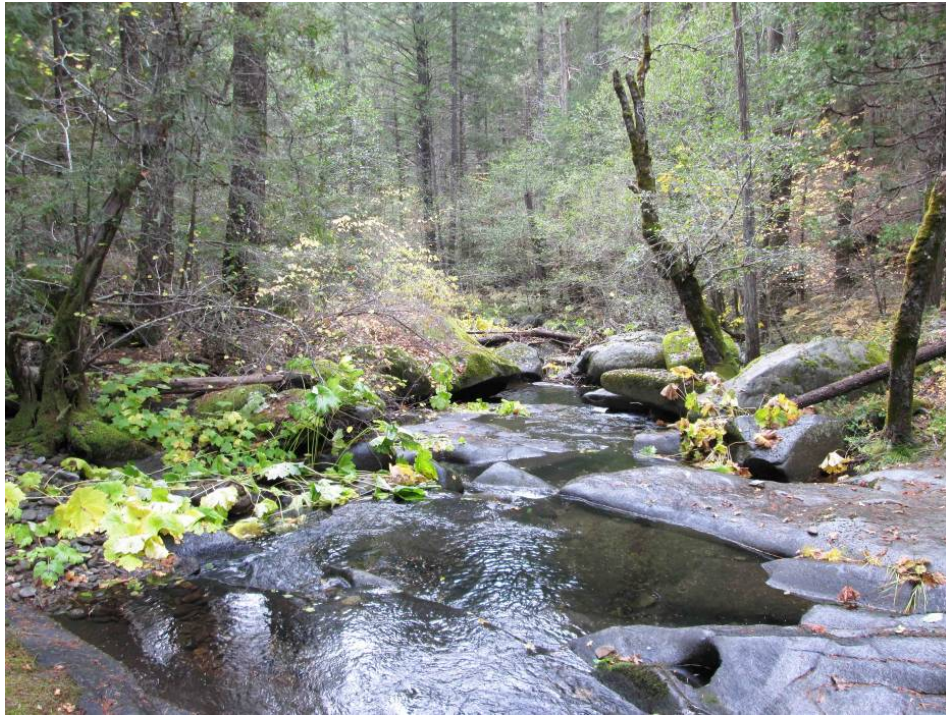
Figure 5. Big Canyon Creek near road 09N44.

<p>Big Canyon Creek</p>	<p>Big Canyon Creek</p>	<p>Approximately 2,960 feet of thinning units border the stream – this is 13.4 percent of the length of the stream.</p>	<ul style="list-style-type: none"> ▪ Perennial stream. ▪ Flows to the west and northwest and into the North Fork Cosumnes River. ▪ Length of the stream is approximately 4.2 miles. ▪ Surface flow is year-round (perennial). Flow can decrease to less than 1.0 cubic feet per second (cfs.) in late summer and early fall. ▪ Aquatic habitat mostly consists of low gradient riffles with pools, runs, and higher gradient bedrock cascades (Figure 5).

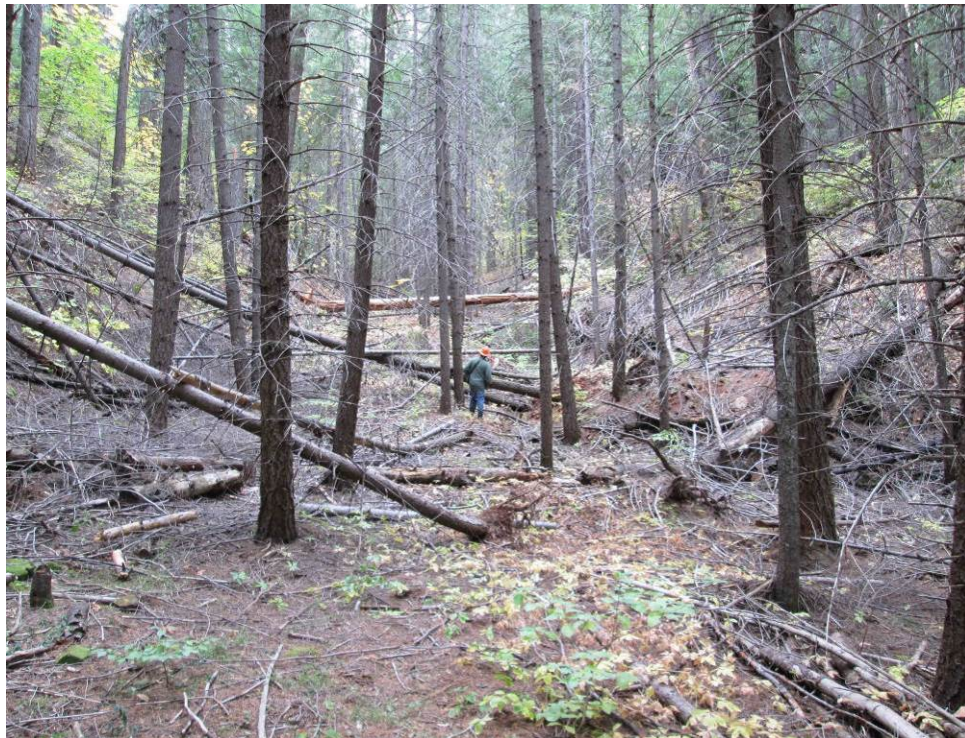
Figure 6. Steely Fork Cosumnes River near road 09N73.

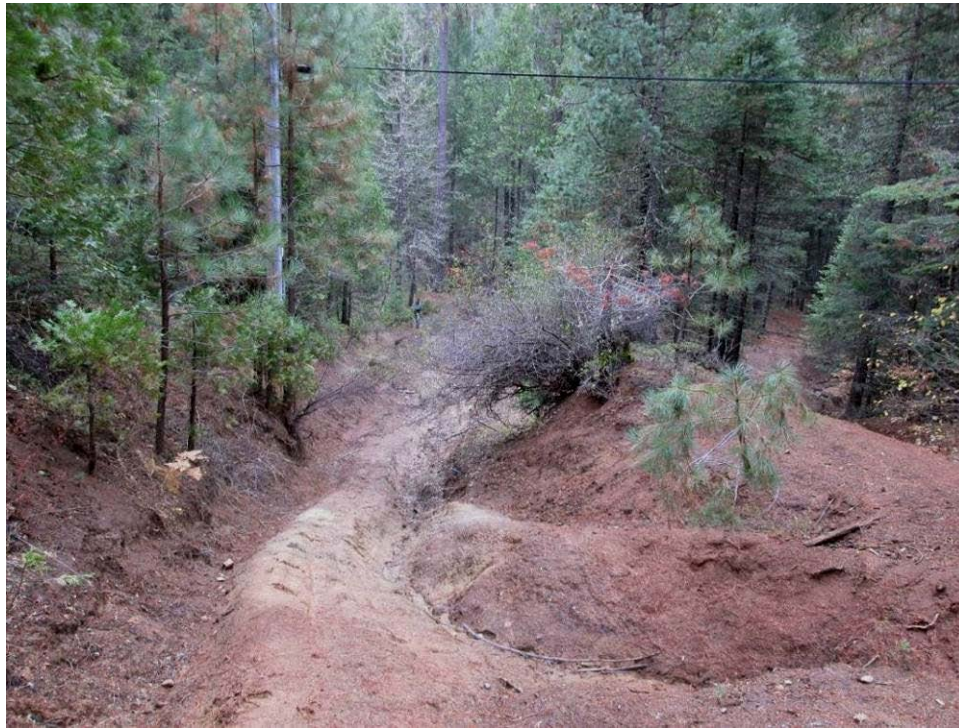
Figure 9. Camping area next to Dogtown Creek near road 09N45D. The large rill in the denuded area (middle of photo) extends to the edge of Dogtown Creek (upper half of photo).

Stream	Features and locations
Dogtown Creek	<ul style="list-style-type: none"> • 2 camping areas (each approx. 0.1 acres in size) are adjacent to Dogtown Creek and road 09N45. The 2 camping areas are less than 0.1 miles from the intersection of roads 09N45 and 09N73.³ • 1 camping area next to Dogtown Creek, which is accessed from a spur road off of road 09N45D. (Figure 9).³ • Road 09N45D, which is 1.1 miles in length, is mostly within the RCA of Dogtown Creek. The road contains a number of landings, as well as crossings of several seasonal streams that flow into Dogtown Creek. One of the stream crossings is failing, and the road is actively eroding sediment into the stream.³ • OHV trail 14E31 is contributing sediment into several tributaries of Dogtown Creek.
Steely Fork Cosumnes River	<ul style="list-style-type: none"> • 1 camping area is approximately 0.4 miles from the intersection of 09N73 and 09N59.³ • 1 camping area and spur road is between 09N73A and the Steely Fork Cosumnes River.³ • Most of road 09N65B, approximately 2.0 miles in length, is within the RCA of the stream.³ • Approximately 1.0 miles of non-system roads, located on north side of the river and approximately 0.4 miles of where road 09N73 crosses the river. (Figure 10). • Several OHV trails are contributing sediment into several tributaries of the Steely Fork Cosumnes River.

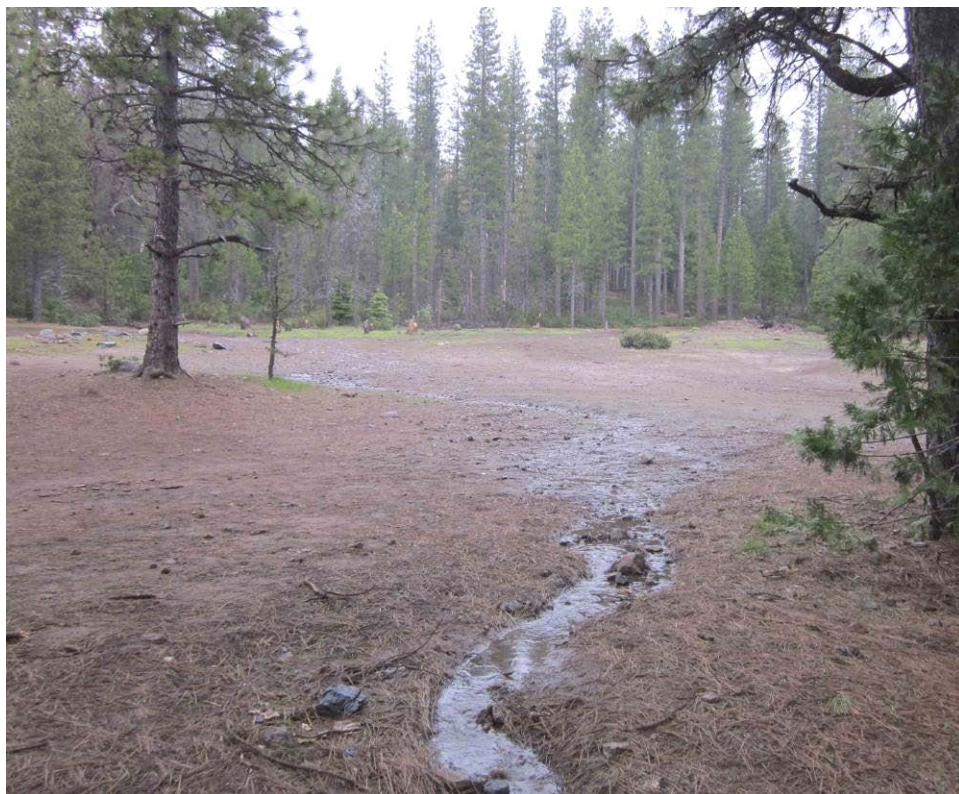
Figure 10. Non-system road near Steely Fork Cosumnes River.

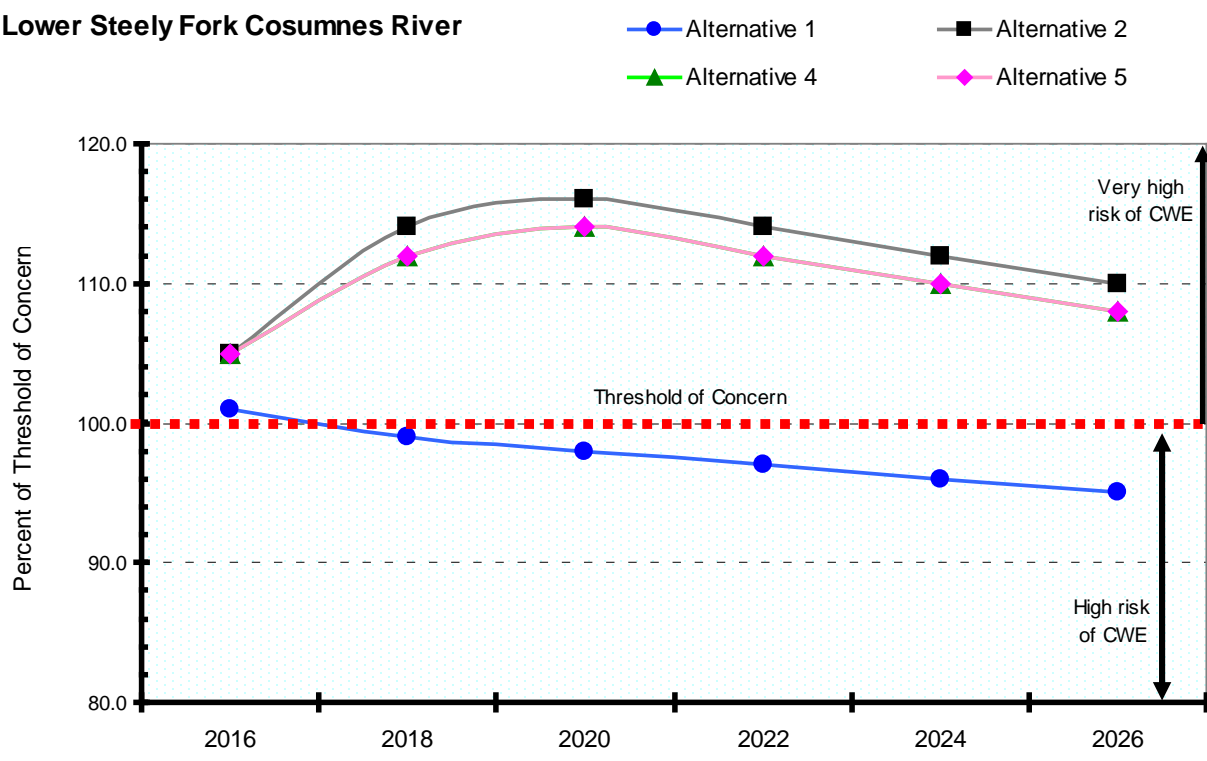
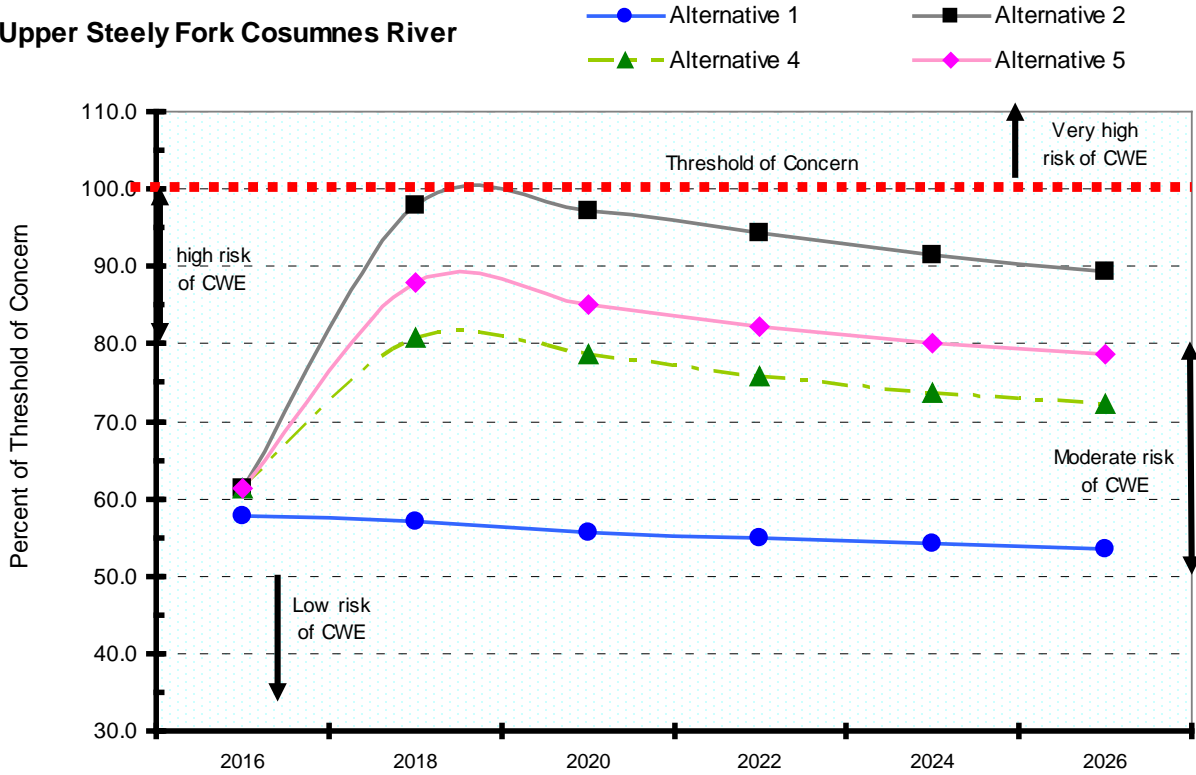
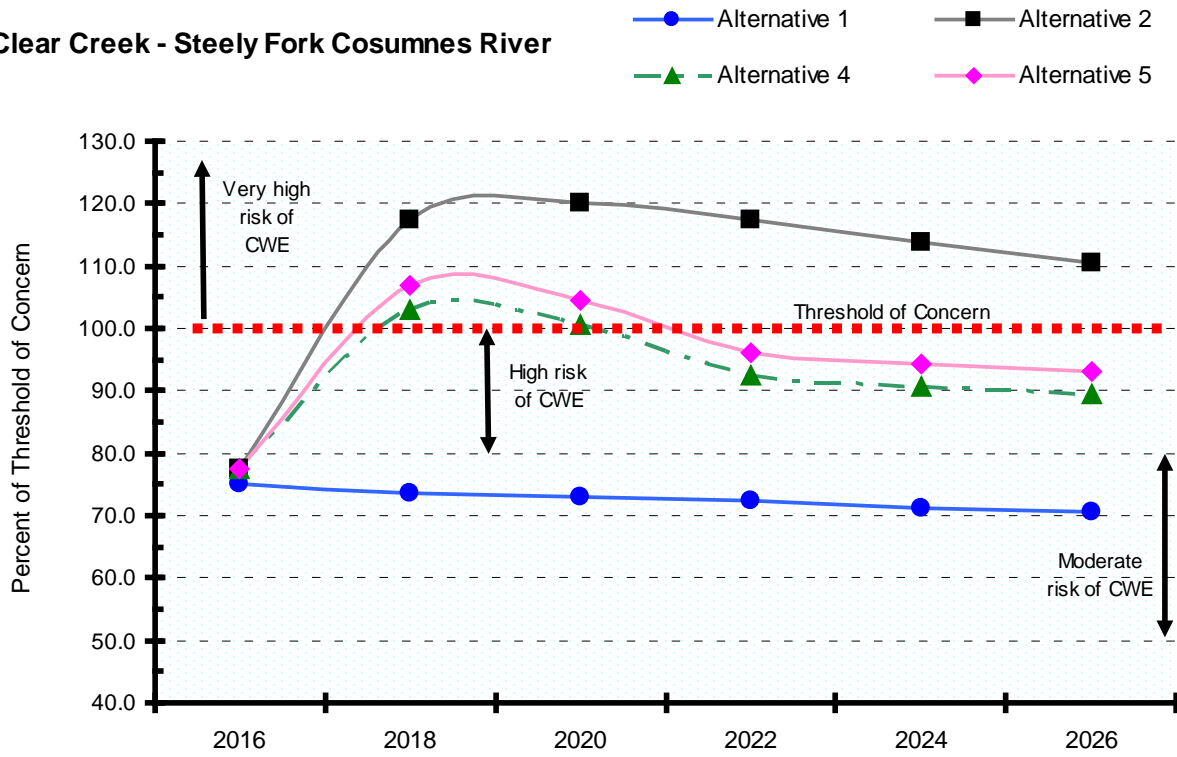
Figures 17 through 23 (next four pages). Percent Equivalent Roaded Acres (% ERA) - expressed as the Percent of the Threshold of Concern (% TOC) - and the risk of Cumulative Watershed Effects (CWE) for the watersheds that contain the Trestle Forest Health Project.

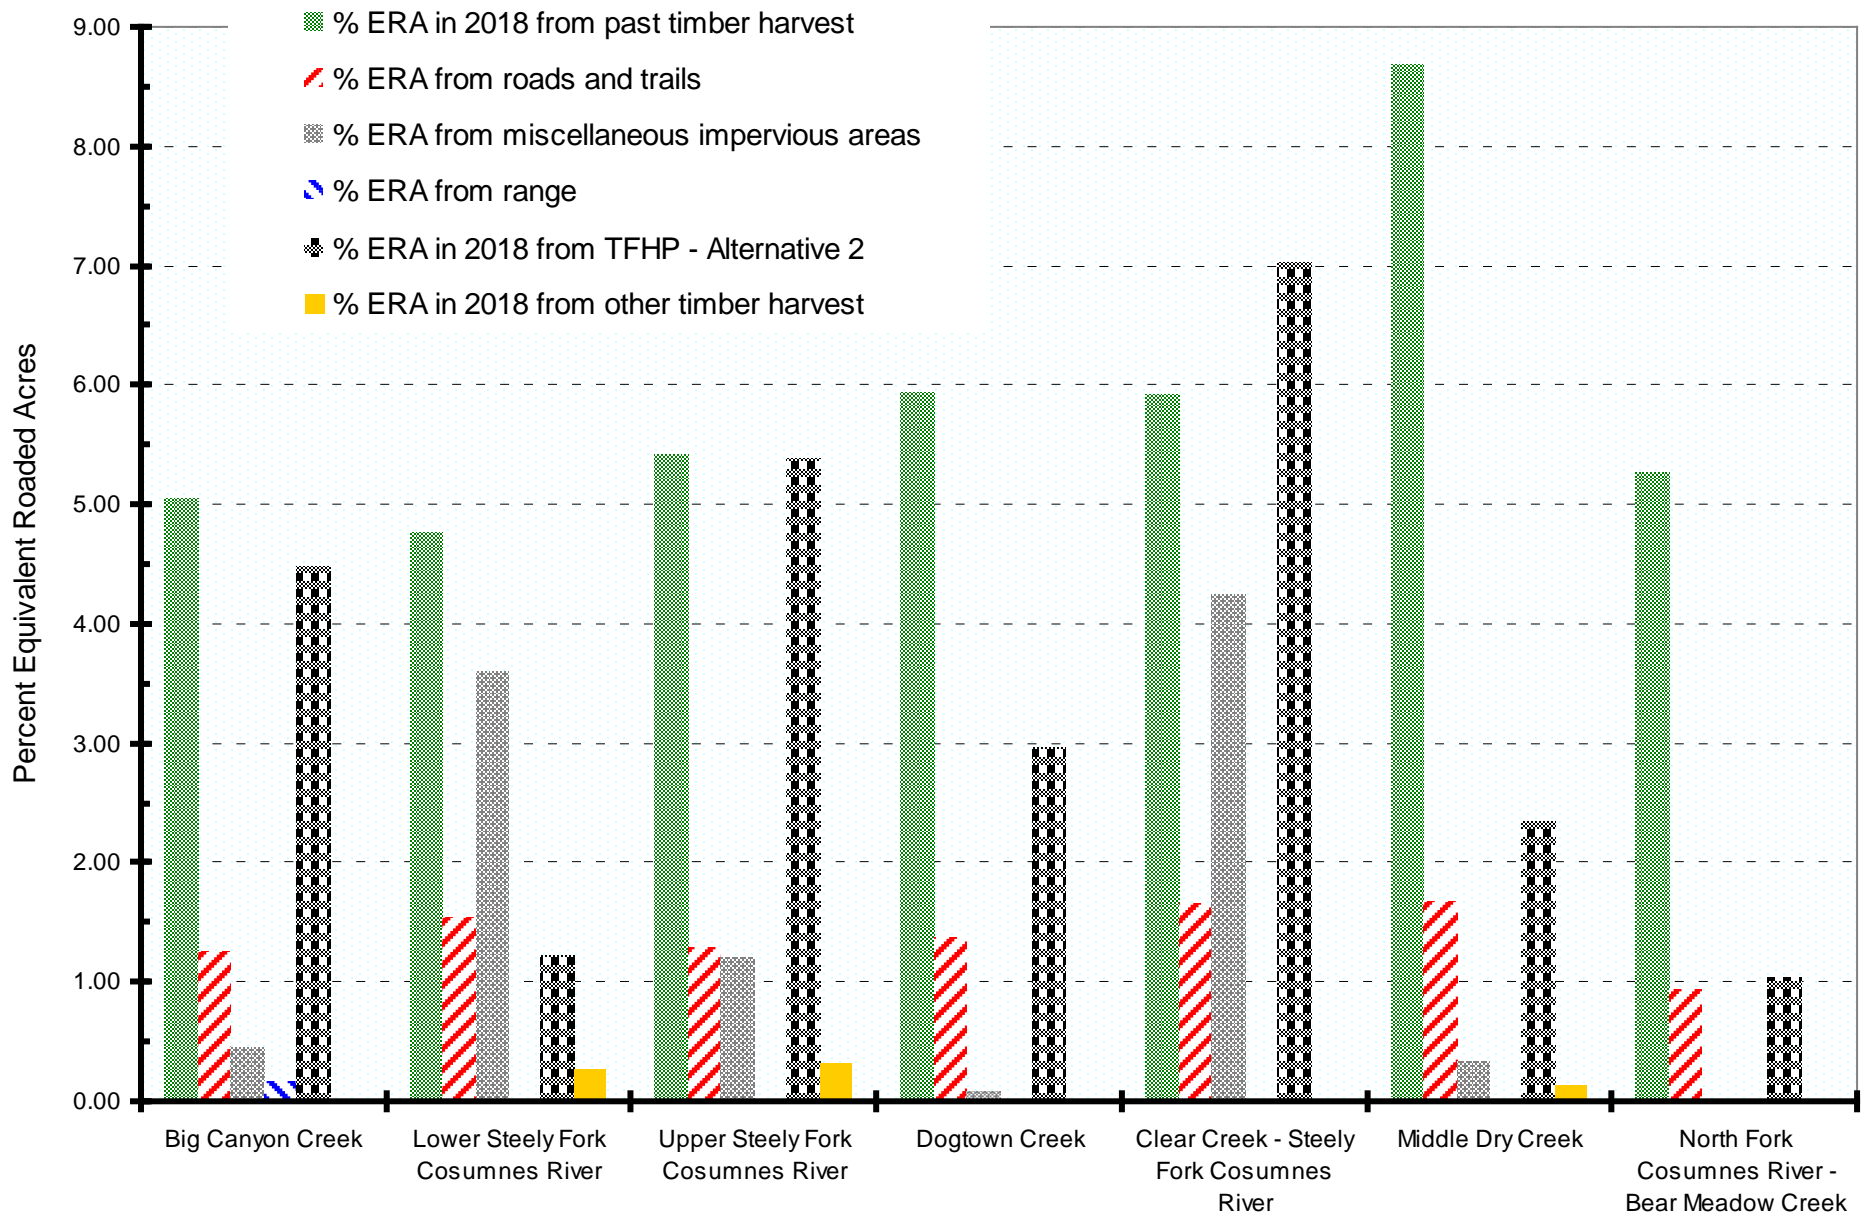
Percent Equivalent Roaded Acres (% ERA) in 2018 for different types of land disturbances in the seven watersheds that contain the Trestle Forest Health Project (TFHP).

- Miscellaneous impervious areas include buildings, parking lots, mining sites, and other denuded and compacted areas.
- There are zero equivalent roaded acres from past fire.
- “Other timber harvest” mostly refers to planned timber harvest on private lands.
