TRESTLE FOREST
HEALTH PROJECT
HYDROLOGY REPORT

October 10, 2014

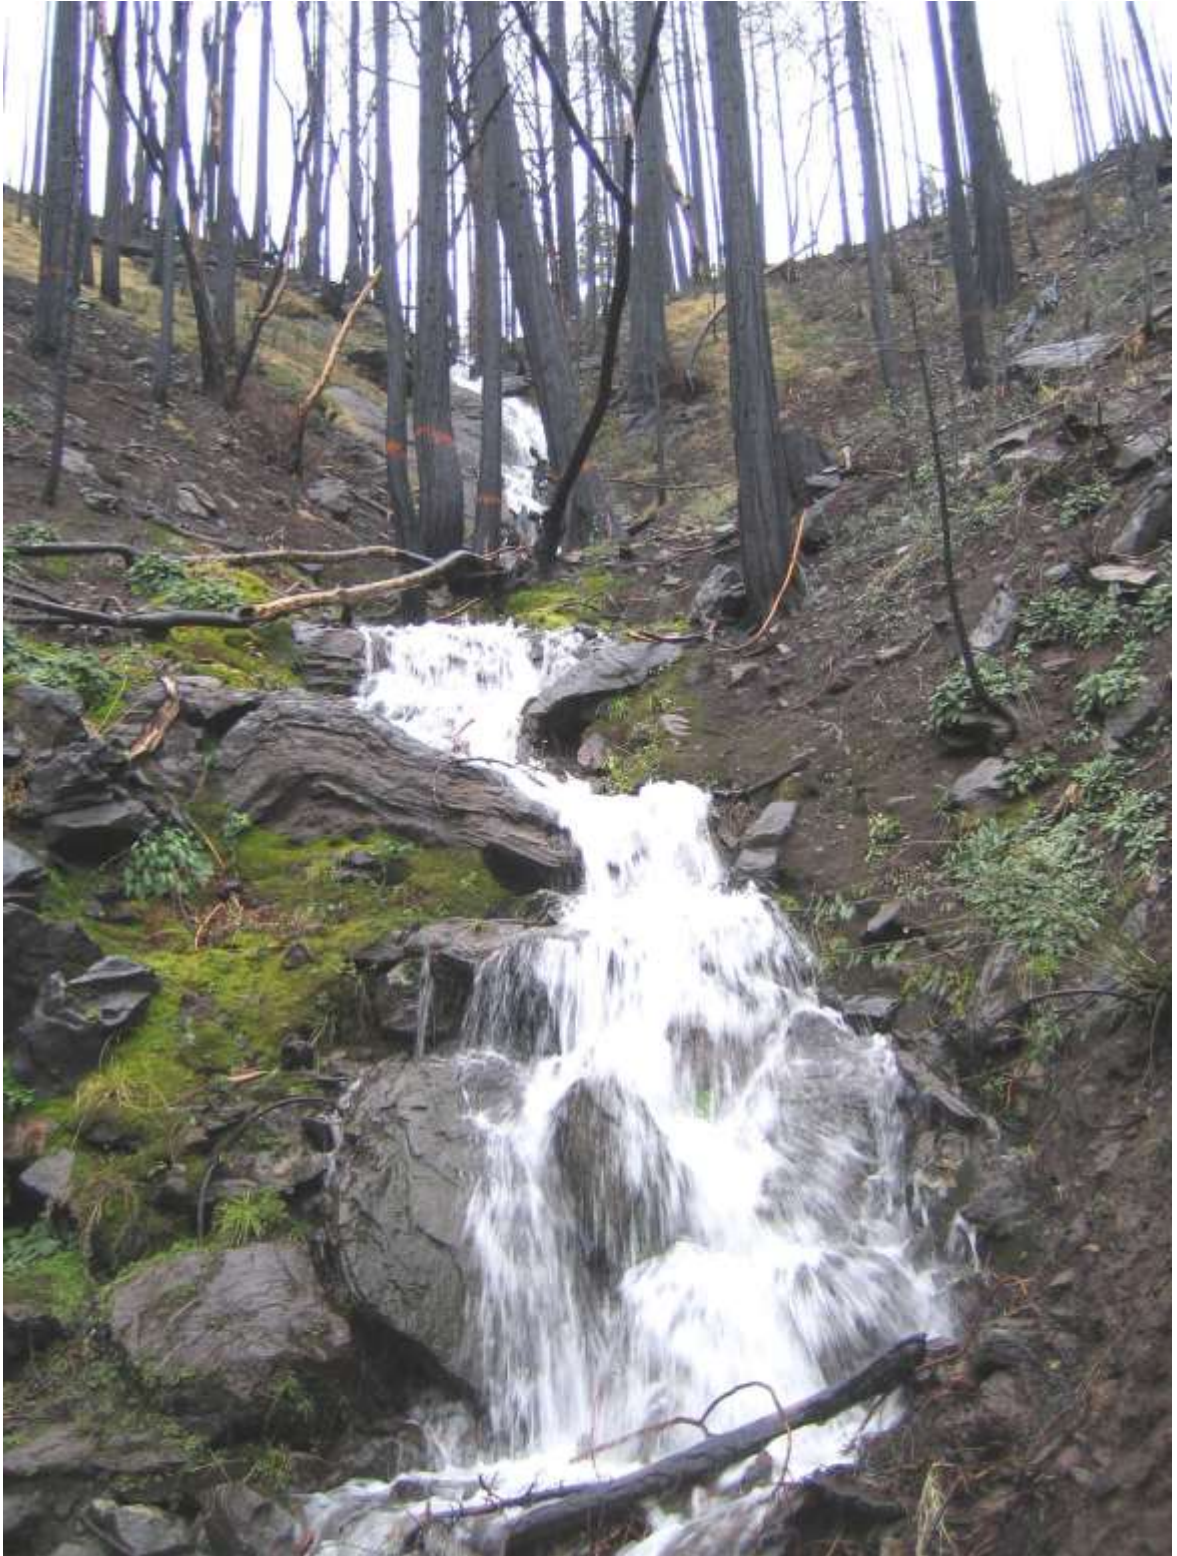
Figure A1-c. Eroding slope and channel in a high severity burn area in the Power Fire. (*Oct. 2004*).

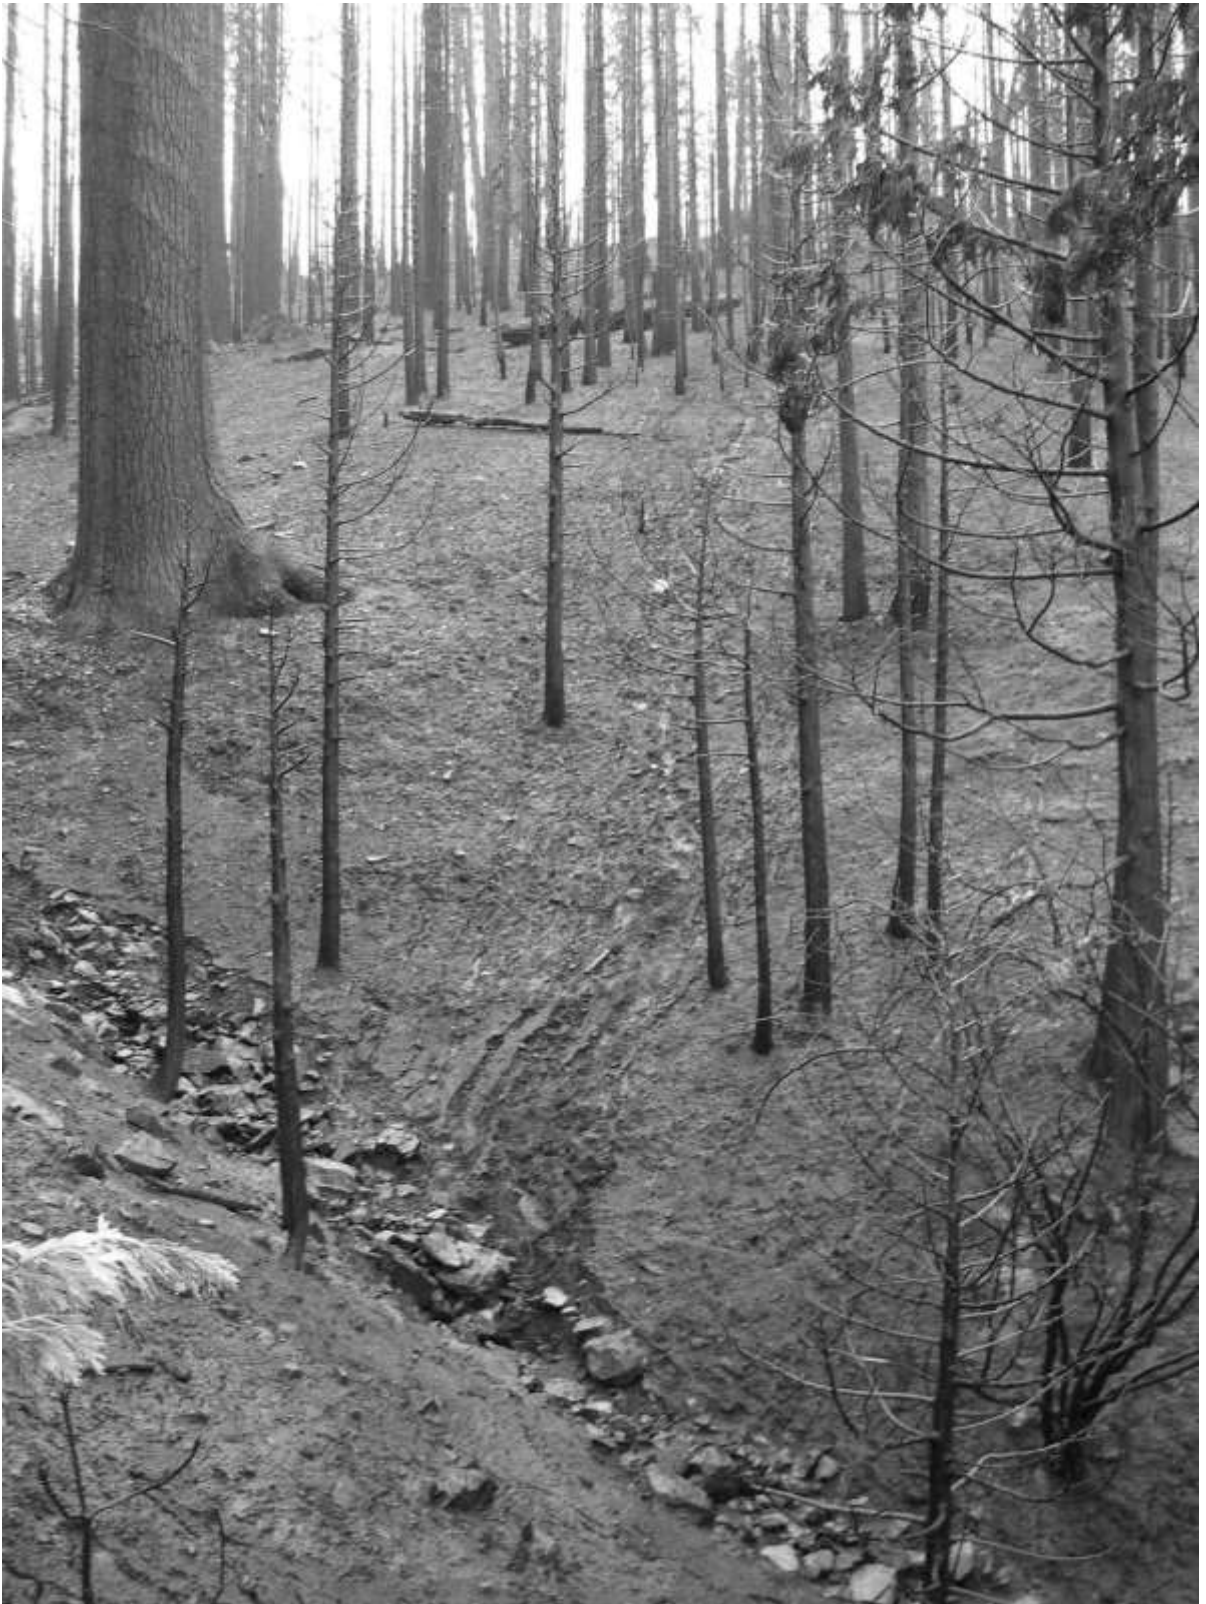
Figure A1-d. Comparison of turbidity of nine streams in December 2004.

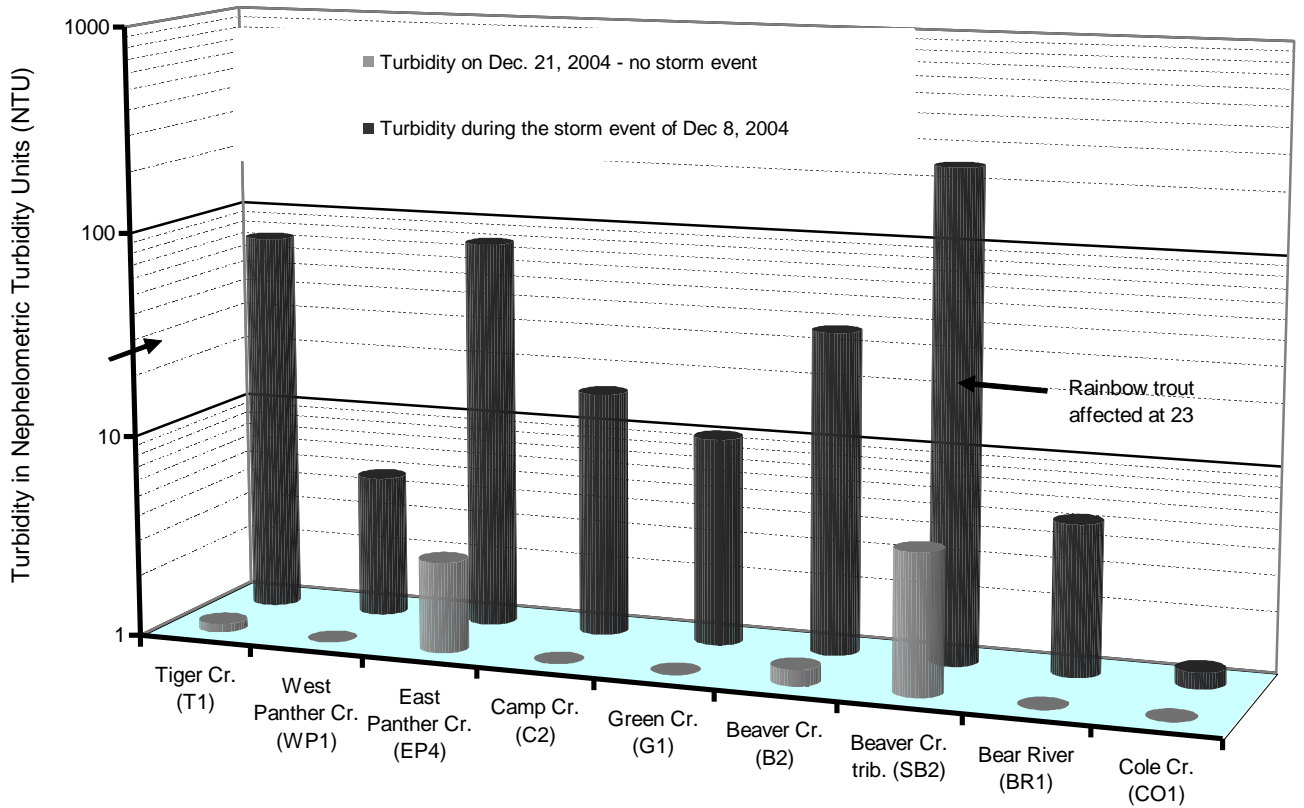
Figure A1-e. Turbidity of water samples of streams during the storm event of December 8, 2004.

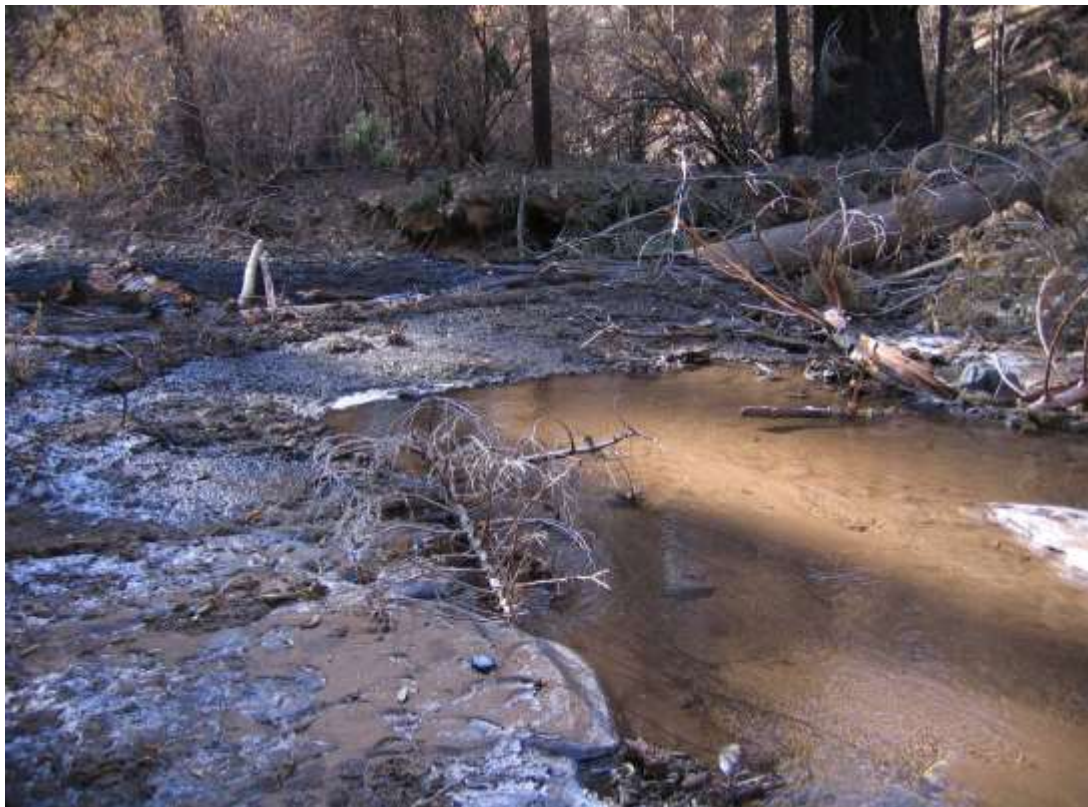
Figure A1-g. Percent of fine-grained sediment in depositional areas of streams in winter 2004/2005.

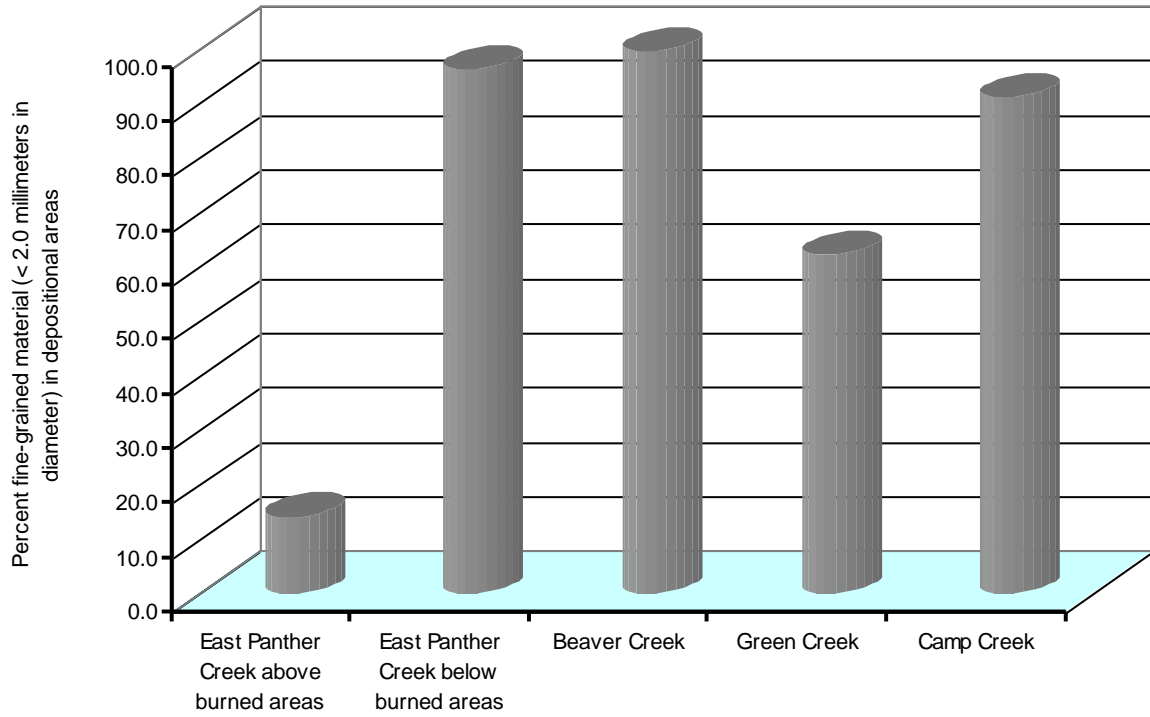
NOTE: Measurements of Beaver, Green, and Camp Creeks were made below areas burned by the Power Fire.
